Effectiveness of CAMANAVA Flood Control Project: A Case Study of Selected Flood Control Structures during Typhoon Gener and Monsoon Rains in August 2012

Abstract

4. Field Observations

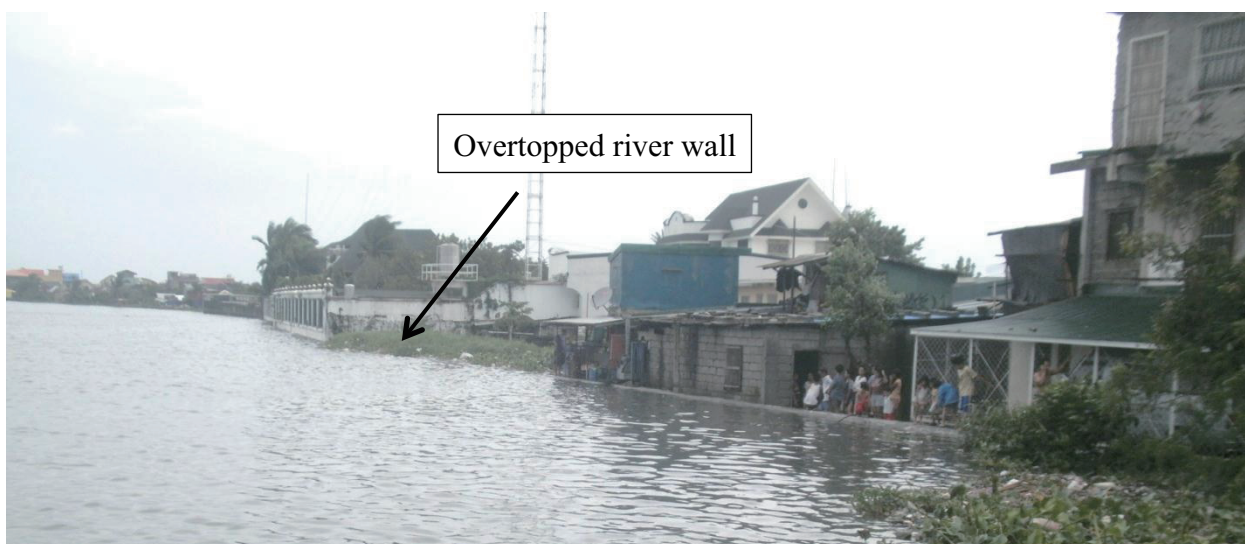
Observations of river wall section in Tonsuya were conducted August 2, 2012, following Typhoon Gener, August 5, prior to the monsoon rain, and August 12, after the monsoon rain. The photos were taken from the Tonsuya Bridge on Rizal Avenue downstream (south) of the observed Tonsuya river wall section. Tonsuya's river wall was raised as part of the CAMANAVA Flood Control Project in order to protect the residents of Tonsuya from Malabon River flooding. Following Typhoon Gener, the observed river wall revealed the river wall height to be inadequate and flooding did occur (Figure 4). Figure 4 shows a section of the river wall approximately 50 meters upstream of the bridge.

Figure 4. Tonsuya river wall immediately after Typhoon Gener (Photo credit: Malabon City, 2012)

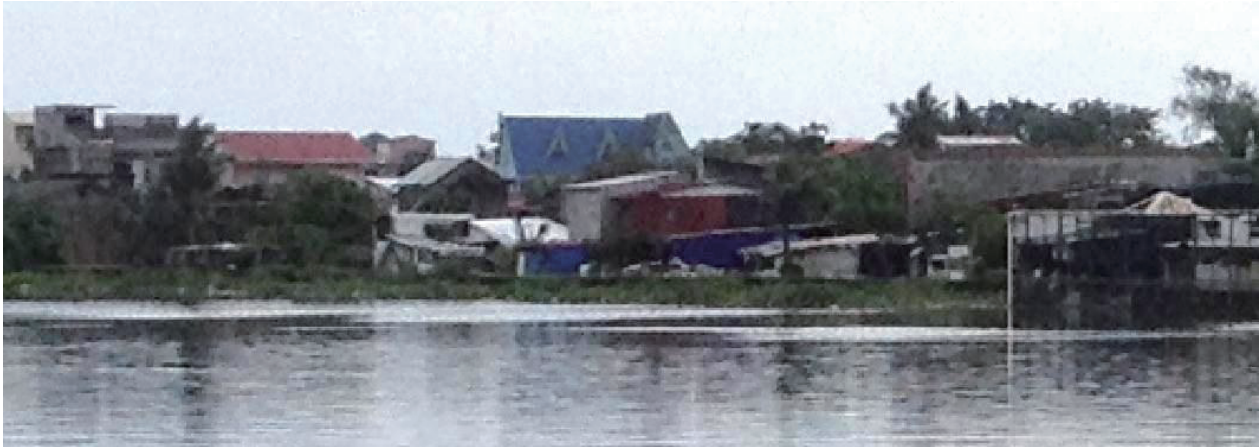
The river remained swollen after Gener rains, but the renovated river wall maintained its structural integrity as displayed in Figure 5. Figure 5 shows a section of the river wall approximately 250 meters upstream of the bridge on August 5, 2012.

Figure 5. Functional river wall upstream in Tonsuya (Photo credit: James Tyree)

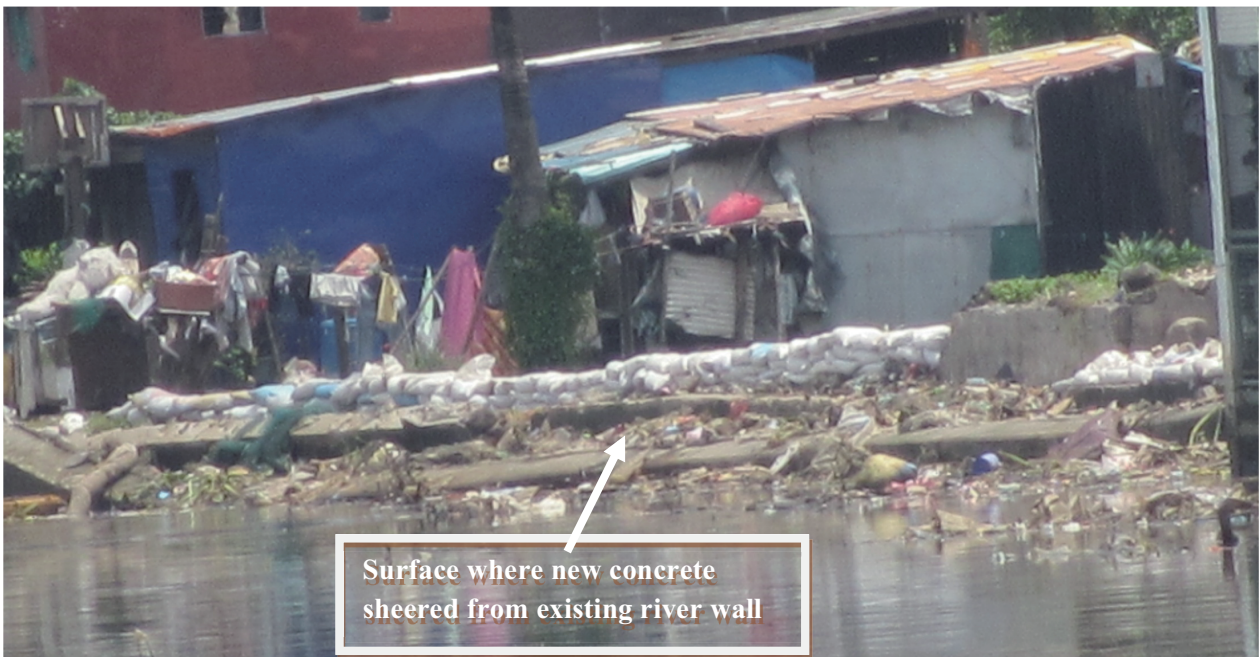
However, when monsoon rains followed the typhoon, extreme flooding occurred as the Malabon River swelled past its crest and overtopped the renovated river wall. For a second time in a span of 7 days, Tonsuya barangay flooded, and residents had to evacuate. Post-monsoon observations were collected on August 12, 2012. The same section of river wall, observed seven days earlier (Figure 6) had collapsed after the monsoon rain event, exacerbating flooding in Tonsuya. As seen in the photo, Tonsuya residents used sandbags to temporarily raise the river wall until permanent repairs can be made.

Figure 6. River wall collapse, sandbags provide temporary protection (Photo credit: Claire Pascua)

In an effort to limit cost and expedite the schedule, DPWH added formed concrete to the top of the existing river wall but did not modify the river wall foundation to handle the added load from the increased river flow, thus causing the river wall to tilt, as seen on the left side of Figure 6 (Bautista 2012b). Figure 6 also shows the sheering of the river wall along the surface of the previous top of river wall. The raising of river walls with formed concrete added to the top is a design flaw in river wall renovations (Siringan, 2012 and Bautista, 2012b).

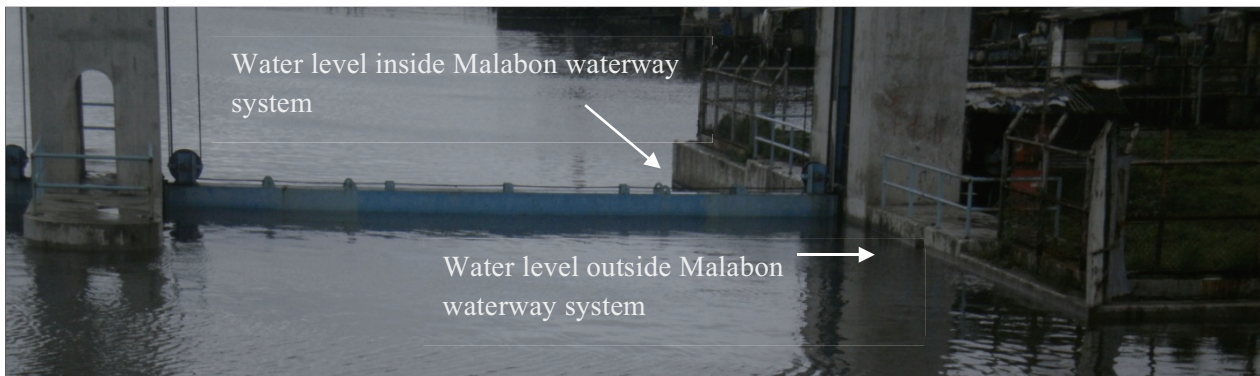
Figure 7 shows the floodgate before Typhoon Gener's rain on July 31, 2012. It was unclear whether the Malabon River overtopped the floodgate during Typhoon Gener landfall or the monsoon rains that followed one week later. However the floodgate did prohibit flow when it was observed.

Figure 7. Floodgate regulating water level (Photo credit: Malabon City, 2012)

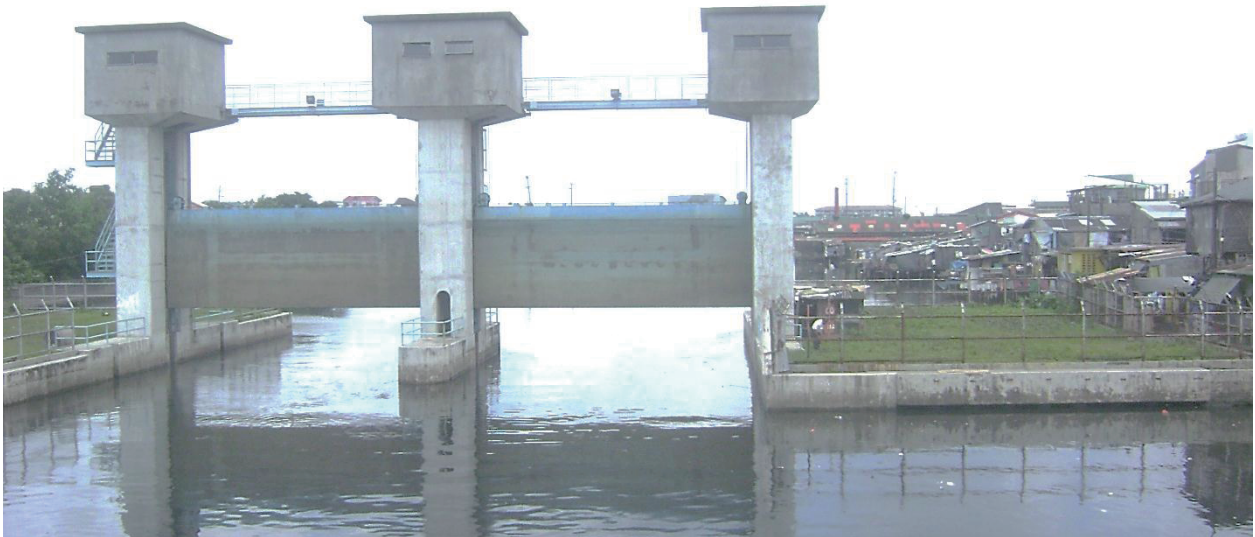
On August 12, 2012, the C4 Floodgate was observed raised and the water level on both sides of the floodgate was approximately 2 m below the top of the side walls of the floodgate (Figure 8). The water level outside the Malabon waterway system had subsided after the respective storm events which allowed for the raising of the floodgate for navigation purposes and hydrological exchange.

Figure 8. Raised C4 Floodgate (Photo credit: Arnel Tenorio)

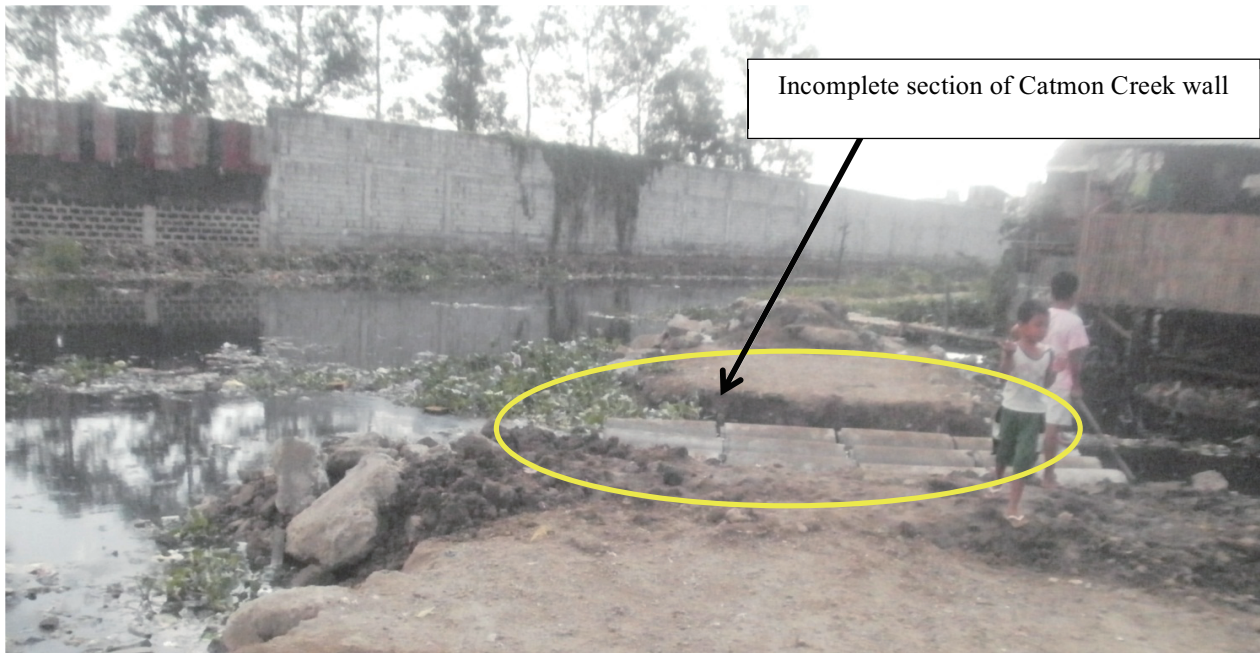
As of August 1, 2012, the river wall along Catmon Creek is 80 percent complete, except for an 800 meter section. Figure 9 shows the incomplete section before Typhoon Gener. The earthen foundation and drainage culverts have been laid but the concrete river wall has yet to be constructed, so residential and informal settler areas along this reach of the creek without protection and exposed to flooding (Bautista 2012a).

Figure 9. Incomplete Section of Catmon Creek Wall (Photo credit: Malabon City, 2012)

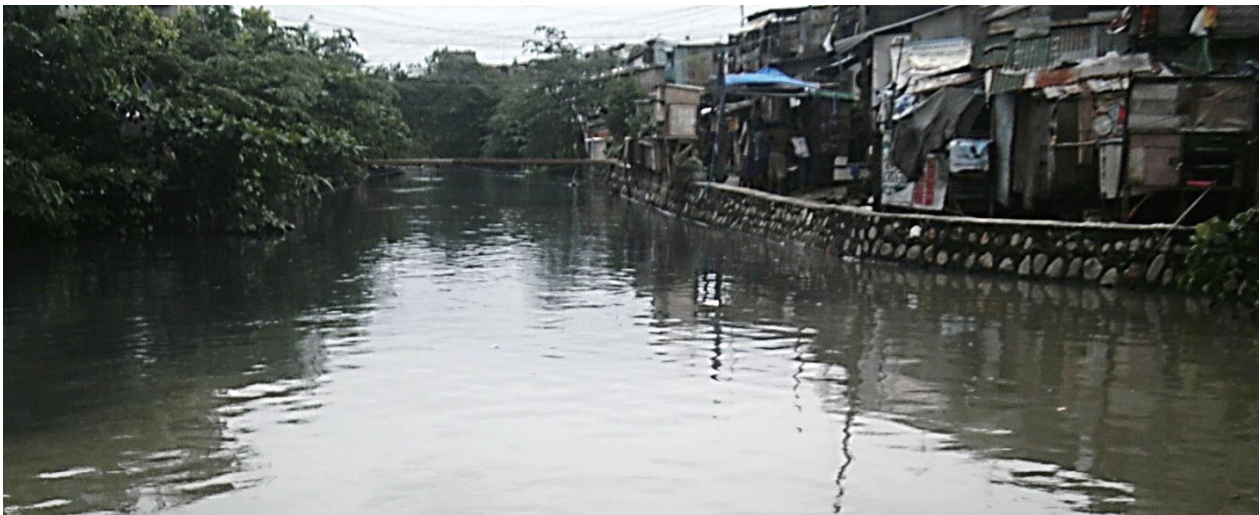
Figure 10 shows a part of the completed section of the Catmon Creek wall approximately 400 meters downstream of the incomplete section, observed on August 2, 2012, one day after Typhoon Gener made landfall in Manila. Comparable swelling of the river occurred along the incomplete section of the river wall. However, after additional precipitation from the monsoon rains a week later, Catmon residents were forced to evacuate because of extensive flooding.

Figure 10. Section of Catmon Creek wall at Letre Canal Confluence on 2 Aug. 2012 (Photo credit: Malabon City, 2012)
