Some Advantages of Transesophageal Echocardiography during Mitral Valve Replacement

Kazumasa ORIHASHI, Yuichiro MATSUURA, Hiroshi ISHIHARA, Yoshiharu HAMANAKA, Yasushi KAWAUE, Taijiro SUEDA, Keiichi KANEHIRO and Takayuki NOMIMURA

The First Department of Surgery, Hiroshima University School of Medicine, 1-2-3, Kasumi, Minami-ku, Hiroshima 734, Japan

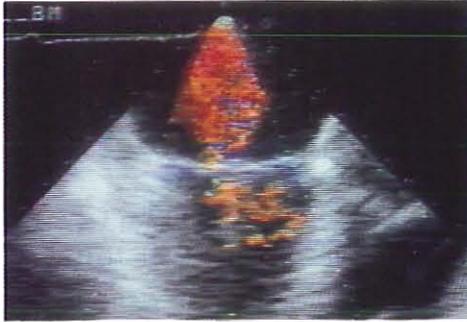
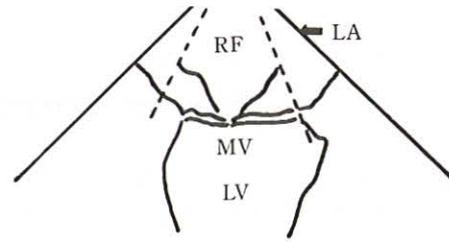
Fig. 1. Transthoracic two-dimensional color Doppler echocardiogram showing mitral regurgitation before valve replacement (case 3). It looks like a flame from the mitral valve orifice and reaches the posterior wall of the left atrium. RF: regurgitant flow, MV: mitral valve, LA: left atrium, LV: left ventricle.

In some cases the regurgitant flow reached the posterior wall of the left atrium (grade 4 by the

conventional grading with transthoracic echocardiography¹). Attention should be paid not to take the drainage flow of the pulmonary vein for the regurgitant flow because they are found closely. Origin of the flame should be clarified in estimating MR.

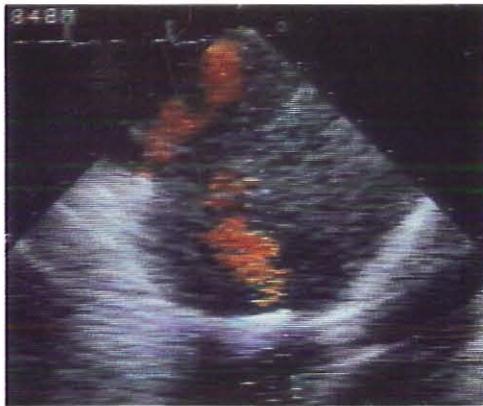
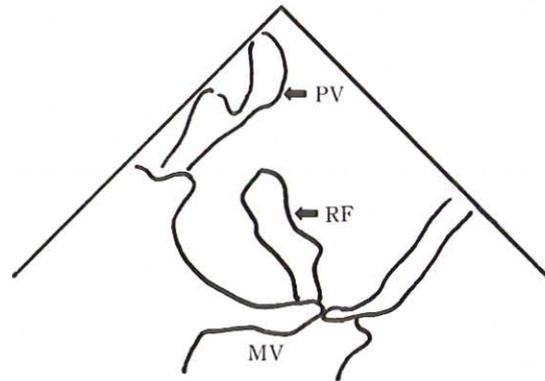
Fig. 2. Transthoracic two-dimensional color Doppler echocardiogram showing drainage flow from the left pulmonary vein (case 5). The flow is recognized near the left auricle and over the mitral valve. It is essential not to take the flow for the regurgitant valvular flow. PV: drainage flow from the left pulmonary vein, RF: regurgitant flow, MV: mitral valve.

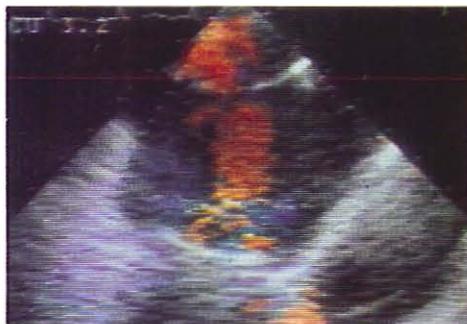
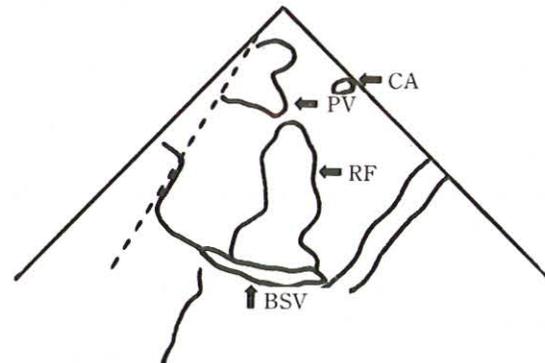
Fig. 5. Transthoracic two-dimensional color Doppler echocardiogram demonstrating regurgitant flow through a Bjork-Shiley prosthetic valve (case 5). RF: regurgitant flow, BSV: Bjork-Shiley valve, PV: drainage flow from the pulmonary vein, CA: catheter for left atrial pressure monitoring.

Mitral regurgitant flow was demonstrated just after MVR in all cases with 2D-CD-TEE, although large v wave was not noted on the left atrial pressure tracing in any case. In most cases, the regurgitant image was modest and originated from just inside of the ring (Fig. 5), which was considered to be transvalvular leak. In case 4, the distribution of the regurgitant flow was large and originated from just outside of the ring (Fig. 6), which suggested paravalvular leak. In cases 1 and 5, very small paravalvular leak was noted.

First, clear images of the prosthetic valves were obtained. Both outer and inner borders of the valvular ring were clearly noted, thus the origin of the regurgitant flow was detected. In most cases the origin of a flame was recognized just inside of the ring, thus the flame was considered to be leak of the permitted quantity due to mechanical construction of artificial valve. Prosthetic valve is originally designed to allow minor leak so that thrombus might be washed out from the surface of the valve. In case 4, however, the flame originated just outside of the ring that indicated paravalvular leak. In this case, two trials of replacement failed because the annular ring was so narrow and rigid that prosthetic valve could not be settled to the annulus. The third trial was successful, but the paravalvular leak was found with 2D-CD-TEE. It was likely due to organic damage of the annular ring after repeated sutures. The patient died of postoperative ischemic enterocolitis 20 days after the operation. However, there was not found any macroscopic valve dehiscence at necropsy. We have no idea other than that TEE could detect a very small regurgitation. In all other cases, TEE could visualize transvalvular leak, while it was not detected by postoperative evaluation of MR with conventional transthoracic echocardiography. This high sensitivity may be the second advantage of TEE. We think this is because the regurgitant flow is directed almost toward the transducer.

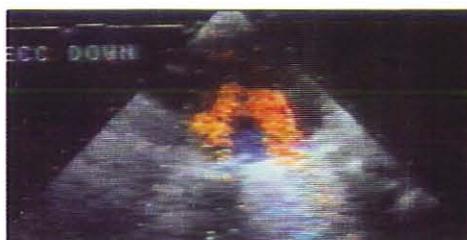
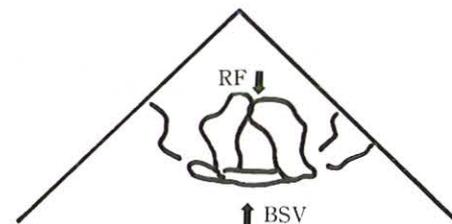
Fig. 6. Transthoracic two-dimensional color Doppler echocardiogram demonstrating paravalvular leak around a Bjork-Shiley prosthetic valve (case 4). Note that regurgitant flow originates from just outside of the ring, and the white image of the ring is slightly stained red due to the overlying regurgitant flow. RF: regurgitant flow, BSV: Bjork-Shiley valve.

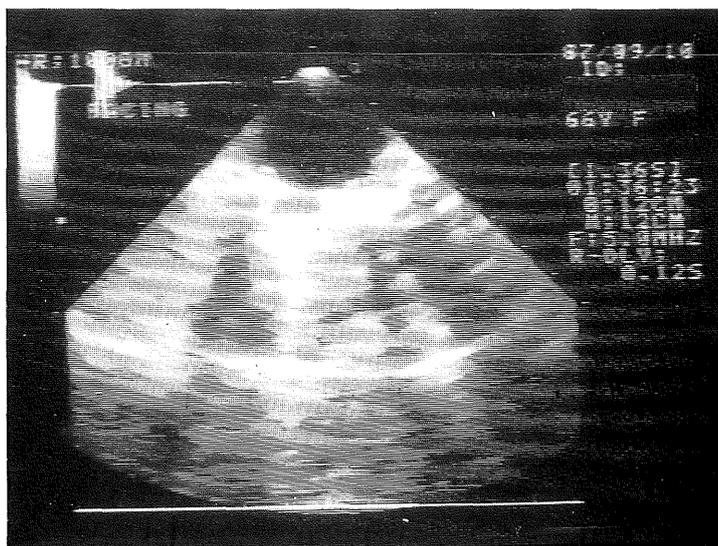
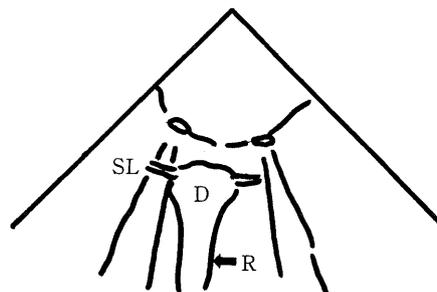
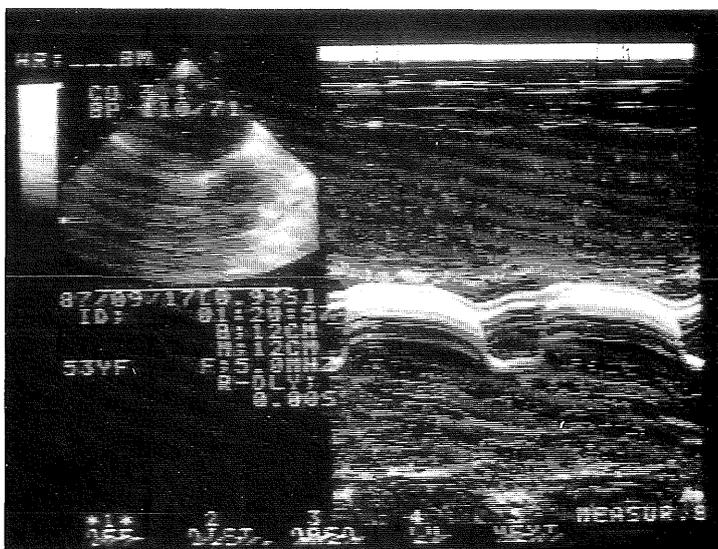
Fig. 4. Transesophageal echocardiogram showing the disc of a Bjork-Shiley prosthetic valve in the mitral position. (a) A two-dimensional echocardiogram of the disc with strong echo, side lobe, and reverberations (case 4). (b) An M-mode echocardiogram of the disc (case 5). D: disc, SL: side lobe, R: reverberations.

3b). The disc was recognized as a highly echogenic arched structure with side lobe and reverberations which showed rhythmical to-and-fro movement (Fig. 4a). M-mode scan of the disc showed various patterns according to the location and direction of the transducer (Fig. 4b).
