Measurement of the flood discharge of a small-sized river using an existing digital video recording system

In this study, a closed-circuit television (CCTV) system, installed for surveillance purposes, is utilized to measure the flow rate during a flood. The procedure to determine both the angle and scale-factor of the camera is described. Then, image analysis techniques, namely the direct visual measurement method, Large-Scale PIV (LSPIV) and Space-Time Image Velocimetry (STIV), are applied to the video images recorded by the CCTV camera. The results of these methods and the conventional float measurement are compared. In addition, the accuracy of the respective methods is discussed. A set of low-quality video images of a flood during a thunderstorm that occurred under the dark ambient conditions (midnight) is analyzed using three image-based methods. The transition of the flow rate during the event is successfully estimated.

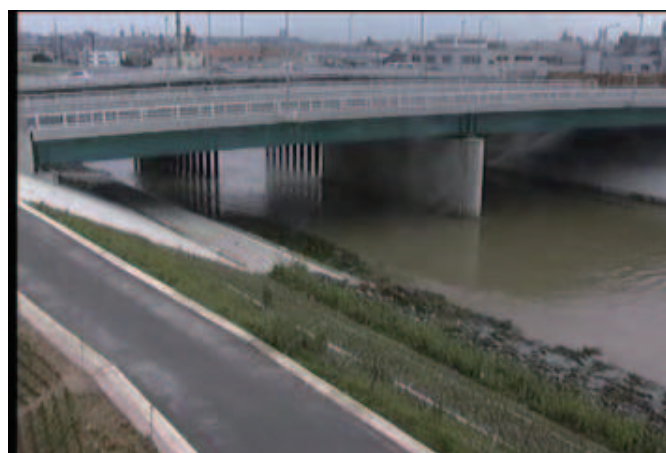
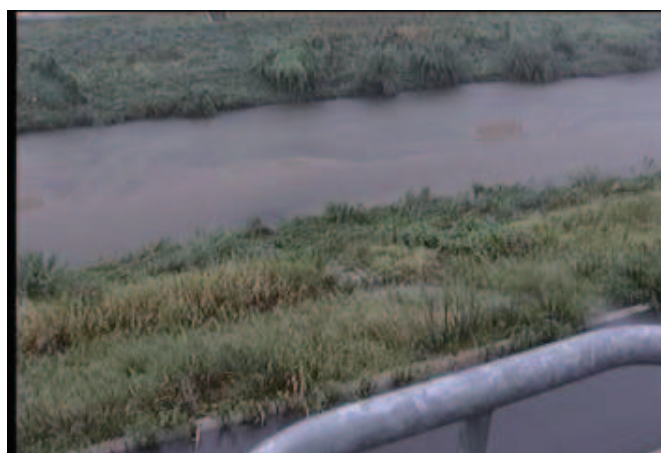
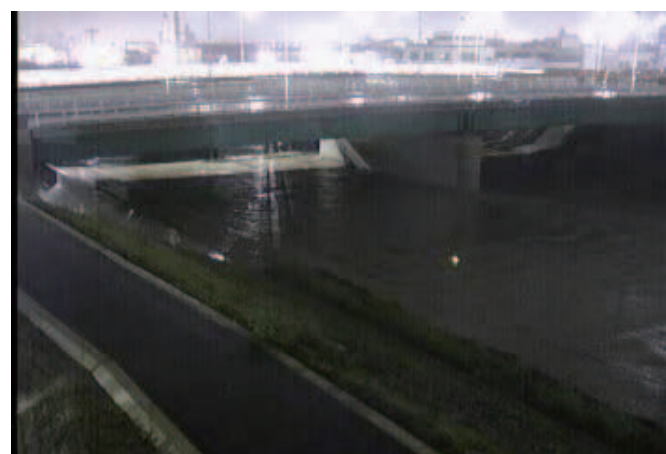
Figure 3

**Fig. 3. Images recorded under different ambient conditions.**

(a) Cloudy (Day, June 16, 2006)

(c) Cloudy (Day, August 28, 2008)

(b) Rain (Night, June 16, 2006)

(d) Thunder storm (Night, August 29, 2008)

on the optical quality. As shown in Figure 3, in the case of the image angle containing a street lamp in the night time, the brightness of the image is adjusted automatically. Due to the wide range variation of the ambient luminance in the open air, an aperture of the CCTV camera is automatically adjusted. The camera tries to improve the image of the lamp and the surrounding illuminated area, and, as a result, the water surface becomes much darker in the recorded image as shown in Figure 3. With this restriction, the recording angle must not contain the street lamp to record the water surface image clearly and to conduct discharge measurement at night. To determine the recording angle, the optical quality of the images recorded at various times and in different weather condition should be surveyed. Based on the discussions above, the downstream angle was utilized for the discharge measurement with the aid of the CCTV image. The image recorded by the CCTV camera was encoded to 720 by 480 pixels, 29.97 FPS (frame per second), MPEG-2 (Moving Picture Experts Group format 2) with 6 Mbps (Mega bit per second) at the camera station. The encoded data were transferred to the image monitor or server via the optical fiber network. The original MPEG-2 data were used for real time preview. However, because the data size per frame was quite a large, stored image data were down-converted to 12 kbps MPEG-4 with 4.995 FPS. Although this procedure reduced the data volume significantly, the total data volume to storage increased with time, so the image data recorded a week before were automatically deleted. The down-conversion of the image data aimed to minimize the data size with reasonable image quality for monitoring by eye. This process deteriorated the image quality for the image analysis because of its poor resolution in both time and space.

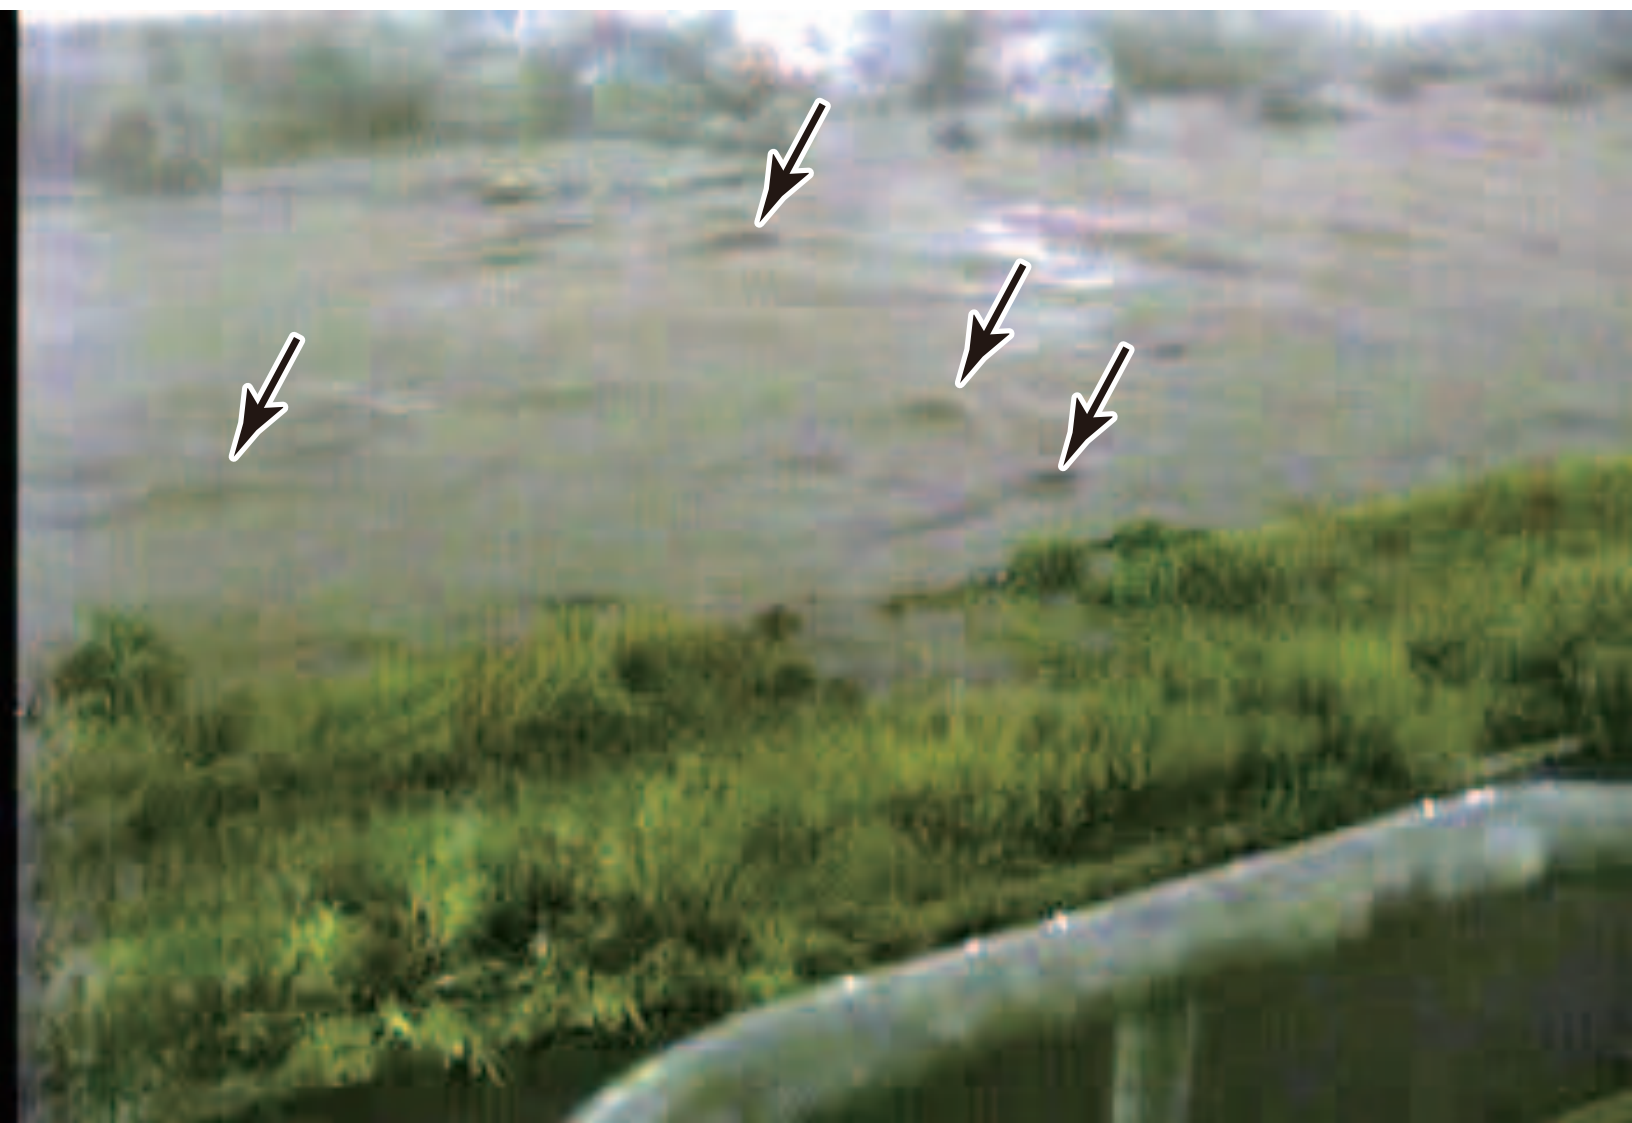
Figure 8

**Fig. 8. Viewing angle of downstream angle used to record the August 29, 2008 event and its positional relation to the float measurement cross-sections.**

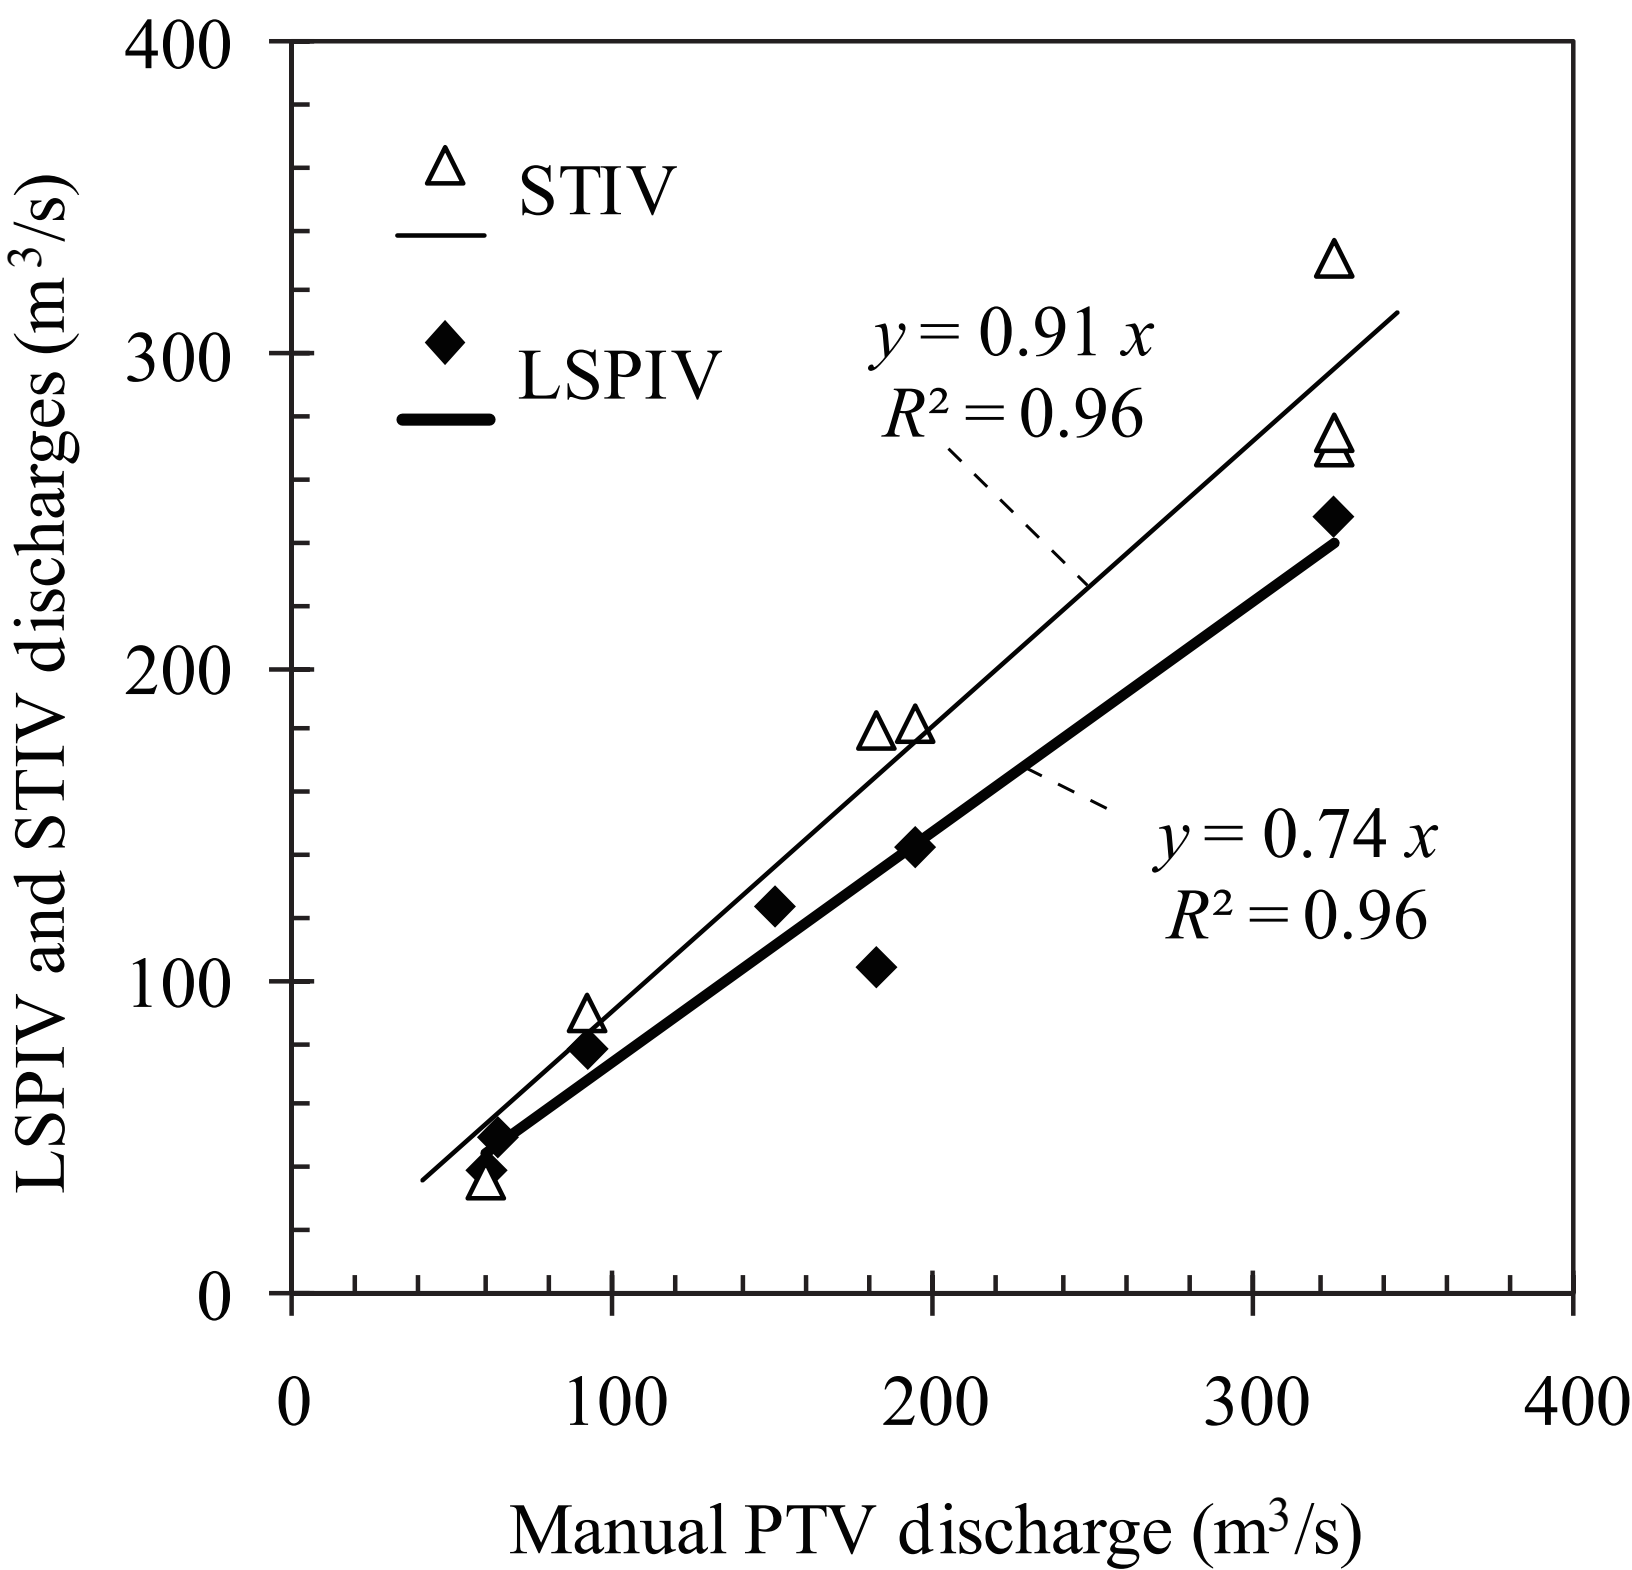
**Fig. 12. Comparison of rating curves for the July 16, 2006 event (based on the float measurement) and for the August 29, 2008 event (based on direct visual measurement results).**

Figure 12 compares the rating curves of the August 29, 2008 event analyzed by the image technique and the June 16, 2006 event obtained by the float measurement. Unfortunately, the rating curve for the June 16, 2006 event contained only a lowering phase because of the delay of the start of the float measurement. The image recorded in June 16, 2006 was shot at the upstream angle, and, therefore, the image contains quite a limited area of water surface with dark color, which made it impossible to estimate the rising stage hydrograph from the water surface image. Compared with the curve of the 2006 event, the falling phase of the 2008 results showed a smaller discharge at the equivalent water stage because of the change of river morphology due to the vegetation settlement and the sedimentation. The cross-sectional widening and dredging around the measuring cross-section was completed in 2005, so the cross-section of 2006 had a larger discharge capacity. However, due to the vegetation settlement and bathymetry changes within two years after the river works (compare downstream sections of Figure 1 and Figure 3), the flow capacity had been reduced, and those changes caused a transition of the rating curve, as shown in Figure 12 quantitatively.
