# Behavior of Geologic Bodies Under Paleostress Field and Groundwater Environment at the Foundation of the Nanakita Dam, Northeast Japan

Hideharu KASHIWAGI

Miocene tuffaceous rocks are developed at the foundation and adjacent ground of the Nanakita Dam in Miyagi Prefecture. During the detailed surveys for the construction of the dam, a large number of open cracks and clay veins were found in tuff breccia and sandy tuff, respectively. In addition, formation of open cracks was observed in the sandy tuff at the time of Miyagi-ken-oki Earthquake on June 12, 1978. Since these open cracks and clay veins will surely cause serious problems for the dam foundation, detailed investigations have been carried out on the formation processes of these geological phenomena, and appropriate foundation treatments have been performed during the construction based on the results obtained.

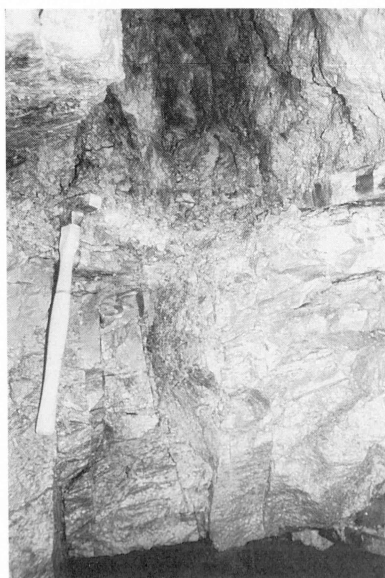
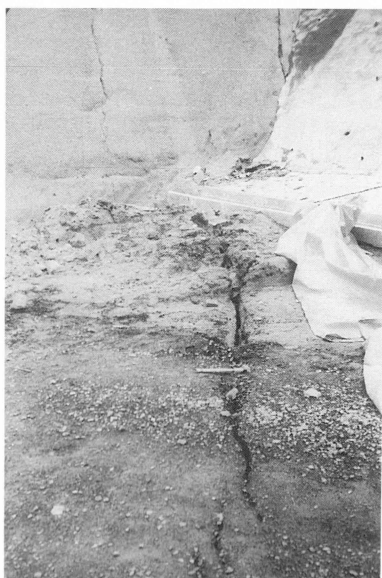
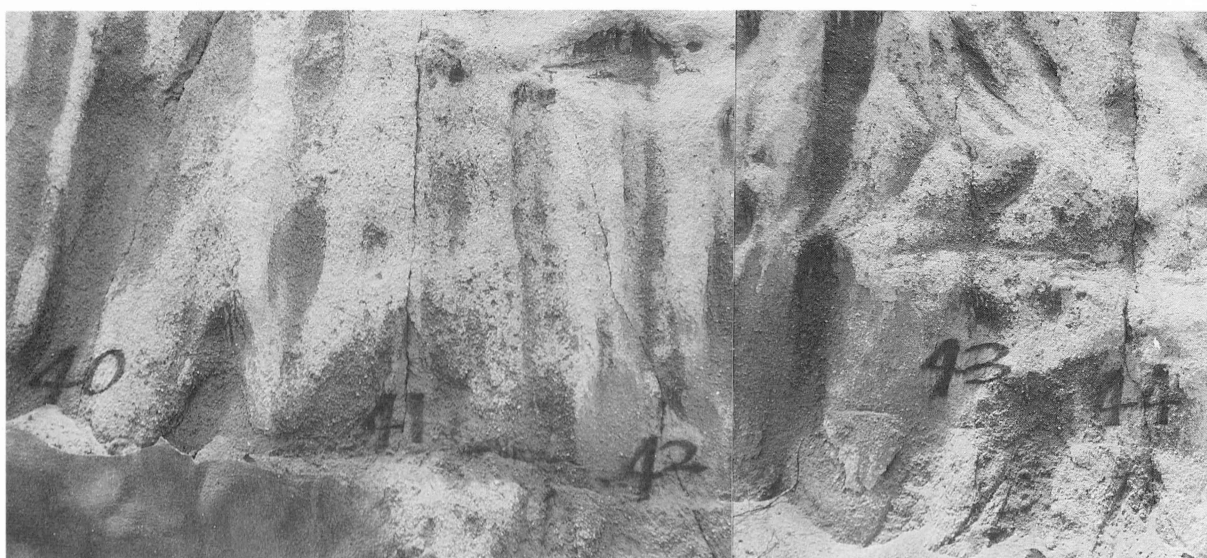
- a. Vertical open crack with about 20 cm width (upper middle part of the photo) is clearly observed only in the tuff breccia. It should be noted that the boundary between the upper tuff breccia and lower tuff is almost horizontal, and development of vertical cracks in the lower tuff.
- b. Fracture formed by the Miyagi-ken-oki earthquake.
- c. Type A open crack (No. 13).
- d. Microphotograph of clay material. Note that the interstitial spaces between quartz and feldspar are filled by clay material and are arranged in certain flow direction.
- e. Clay veins in sandy tuff. Note that the numbered vertical fractures have been formed by rainfall action, which washed out the preexisted clay materials, i.e. clay veins.

several meters to 20 m and the thicknesses are mostly in the range from 1.1 to 5.0 mm as shown in Table 2. In general, those less than 3 mm in thickness consisted of brown clay material, whereas larger ones contained fragments of country rock. Some typical occurrences of these clay veins are shown in Plate e.

- (1) The whole area of the right bank from the upper part of the slope to the peak.
- (2) The vicinity of the right bank relocated road shoulder.
- (3) The surface of the unexcavated table.
- (4) The interior of a test adit (DRT-6).
- (5) A single fracture of maximum width of 5 cm running approximately 60 m in the upstream direction on the surface of relocated road at the right bank, on the upstream side of the unexcavated table(see Plate b).
