Title	Analysis of Hydraulic and Geomorphic Conditions Causing Railway Embankment Breach due to Inundation Flow
Author(s)	Tsubaki, Ryota; Kawahara, Yoshihisa; Sayama, Takahiro; Fujita, Ichiro
Citation	Journal of Hydroscience and Hydraulic Engineering , 30 (1) : 87 - 99
Issue Date	2012-05-01
DOI	
Self DOI	
URL	https://ir.lib.hiroshima-u.ac.jp/00039096
Right	Copyright (c) Japan Society of Civil Engineers
Relation

ANALYSIS OF HYDRAULIC AND GEOMORPHIC CONDITIONS CAUSING RAILWAY EMBANKMENT
BREACH DUE TO INUNDATION FLOW

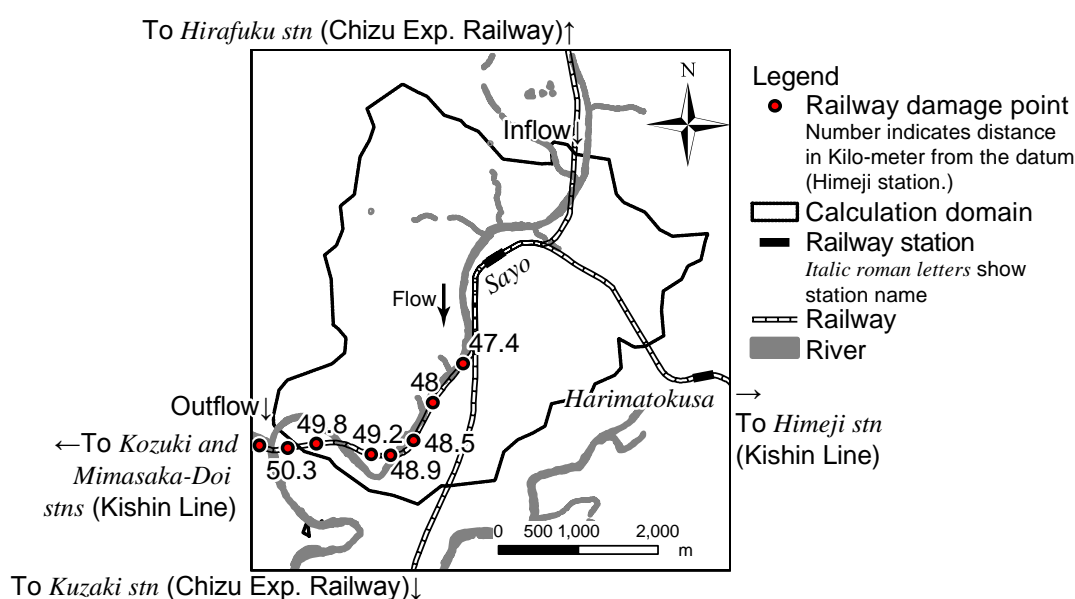
Fig. 3 Locations of railway embankment damage.

Damage to railway embankments caused by inundated flows occurred mainly along the area where the Sayo River and Kishin Line run parallel in the outskirt of Sayo-cho district, in which rainfall was extremely concentrated. Most of the damage occurred within the reach of about 13 km between Harimatokusa and Mimasaka-Doi Stations; the damages are ballast flushed away at 56 points, 13 slope failures and sediment influx and 9 severe breachings of embankment, etc. It should be noted that damage to ballasts and embankments took place to a greater degree between Sayo and Kozuki Stations since inundated flow directly hit railway lines in this area. Fig.3 shows locations of the railway damage as filled circles and the Sayo River and the Kishin Line. The numbers beside the filled circles indicate the kilopost of the Kishin Line. According to the field research (Kaneko (4)), the heaviest damage was observed at 49.2 kp, where an embankment about 2 m in height was washed away over 140 m and ballasts were damaged over 60 m beside the embankment breached area. As a result the railways became twisted and suspended because of the hydrodynamic forces due to the inundated flow as shown in Fig.1a.

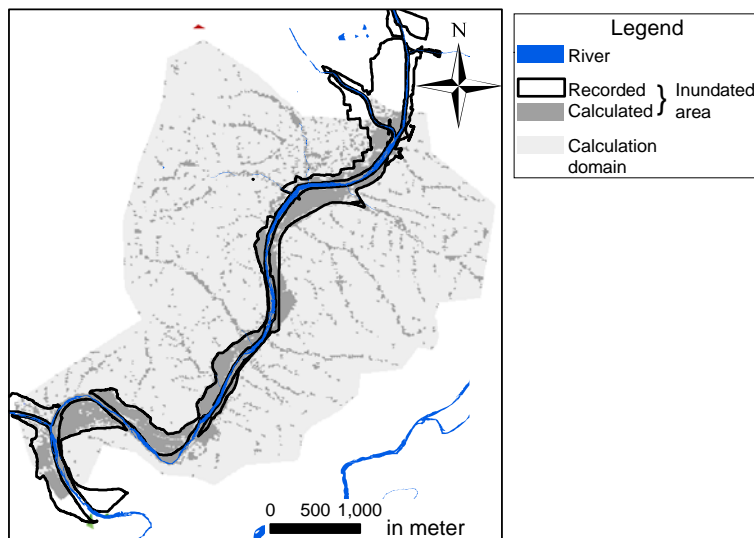
Fig. 8 Comparison of calculated and recorded inundated areas.

To validate the inundation flow model, the calculated results are compared with the inundation records. As shown in Fig. 8, the calculated inundated area almost corresponds to the record of the inundation area. In Fig. 9, the local water stage and the water depth of calculated and recorded inundated water stages and water depths are compared. The calculated water stage stands for $h + z$ in the basic equations. The mean absolute error is 0.28 m, and the magnitude of the error is smaller than, but comparable to, the magnitude of inundated water depth, 1 m. The discrepancy between the calculated and recorded water stages may be related to the error of LiDAR data used in the topography data used for the calculation. Moreover, there is a difference in the definitions of calculated and recorded water depths, namely the calculated water depth is a cell averaged quantity but the recorded water depth denotes the local water depth around obstacles and this caused an under estimation in the calculated water depth shown in the right side of Figure 9.

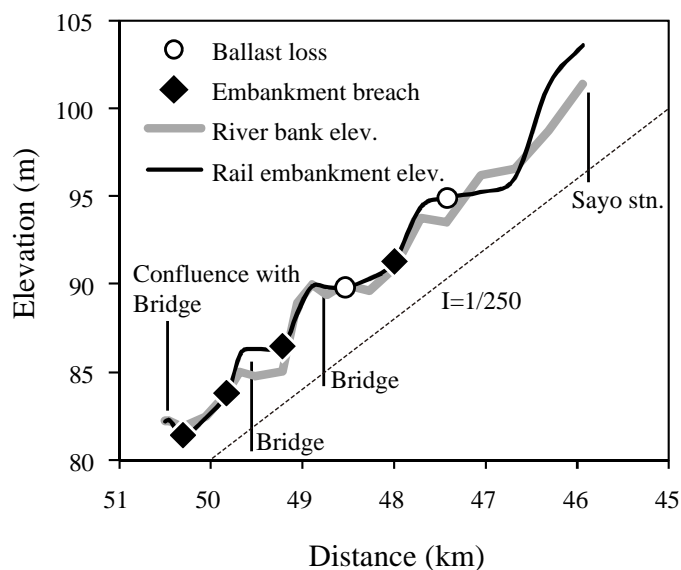
Fig. 10 Longitudinal elevation profiles of the railway and the riverbank. The cross-sections where the river and railway intersects are indicated as the 'bridge'.

To understand the fundamental relationship between the railway embankment damage and topography, longitudinal elevation profiles of the railway embankment and the river bank are compared in Fig. 10. The elevation shown here was based on the LiDAR data which has an elevation accuracy of 0.15 m. As shown in the figure, the elevation of railway embankment is similar in profile to the river bank elevation. The ballast loss due to the overflow, depicted as open circles, was observed in the regions where the railway embankment shows a comparatively mild and constant slope. On the other hand, the location of the embankment breach damage, shown as filled diamond symbols in Figure 10, corresponds to the convex downward large curvature region of the railway embankment. In the area of mild and constant slope embankment, the flood water overflowed over a relatively large segment with a low overflow water depth. However, in the convex downward segment, the overflow of the inundated water was concentrated in the

bottom of the convex, which made the overflow water depth comparatively large. This concentration of overflow caused the embankment breach.

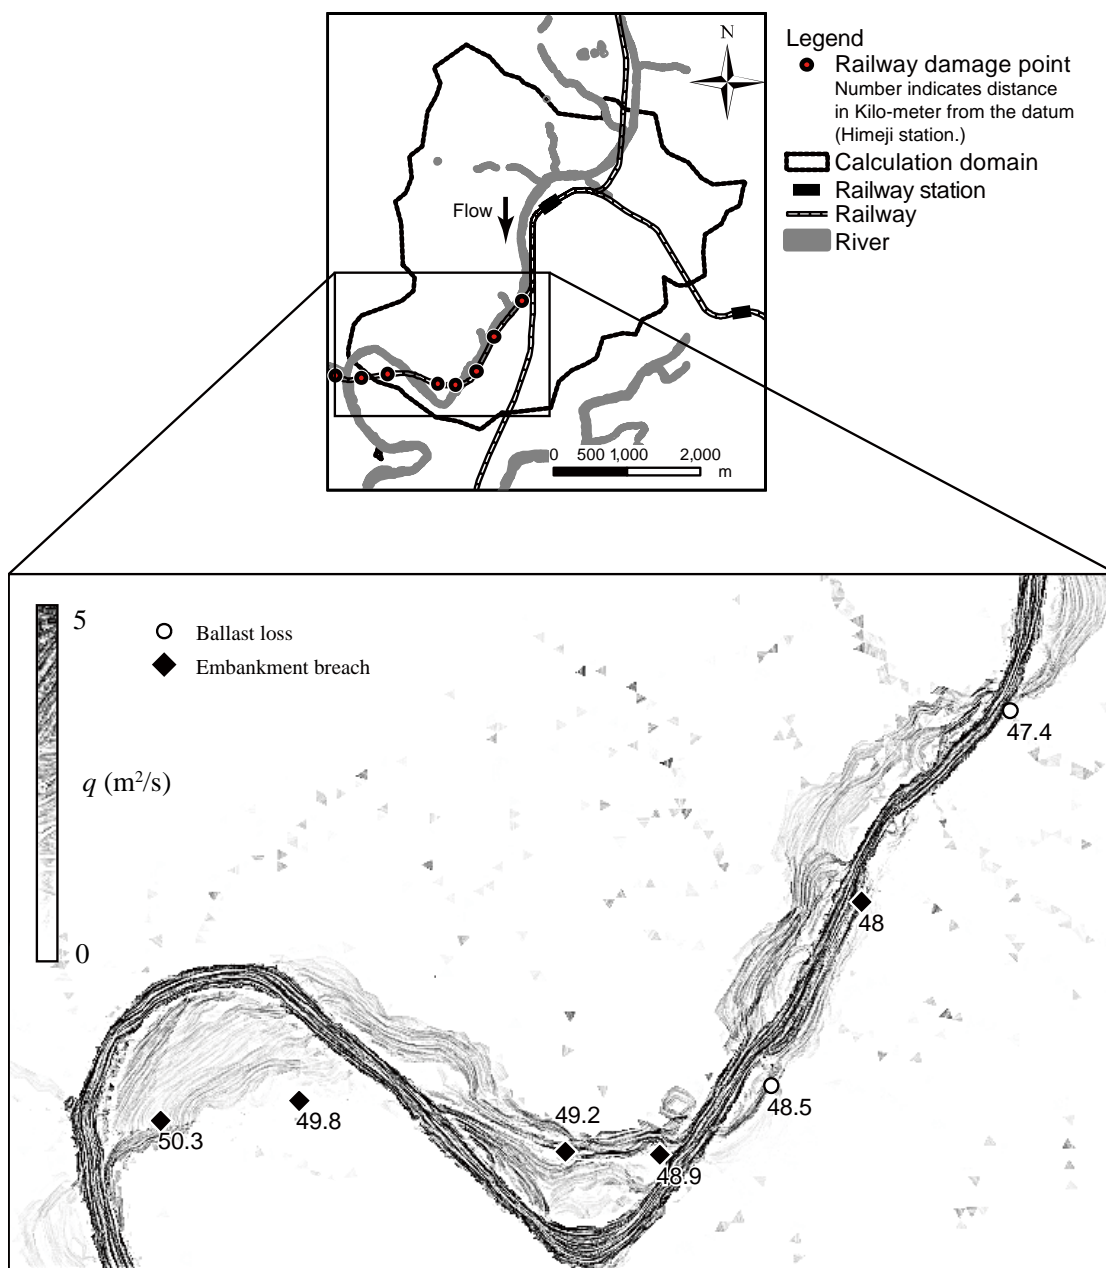
Fig. 11 Flow structure visualization using LIC technique. The direction of texture corresponds to the flow direction. The density of texture represents the magnitude of flow (unit discharge q).

Fig. 11 depicts the structure of inundation flow at the moment around the peak inundation period is depicted. The flow structure is visualized using the Line Integral Convolution (LIC) technique (Cabral and Leedom (20)). Here, the direction of texture corresponds to the local flow direction, and the density of the texture correlates with the local flow discharge per unit width. The dense (darker) meandering path in Fig. 11 corresponds to the river course. The light gray (lighter) path-lines surrounding the river course indicate the course of the inundated water that flowed on the flood plain. The numbered circles and diamond symbols in the bottom figure in Fig.11 depict the location of the railway damage. The points where railway embankment was damaged correspond to the area where the inundation water flowed in a concentrated manner. This local flow concentration is regulated by a topographical structure, namely the slope of the surrounding mountains. The points labeled with 47.4, 48 and 48.5 are located in the boundary of the inundation flow, and these points correspond to the areas where comparatively little damage was observed. The point 49.8 is isolated from the inundation flow. In this area, ballast loss was observed after the rainfall event, and such damage was due to not the overflow water from the river course but the direct runoff from the adjacent mountain slope. At 49.2 and 50.3 points, the inundated flow completely enclosed to these damaged segments. The consecutive and comprehensive flow of inundation around the railway path is a crucial factor in causing severe breaching of the railway embankment at 49.2 and 50.3 points. The damage at 48.9 was due to the river bank erosion, so there is no direct relation between the damage and inundation flow at this point because river bank erosion was not modeled in the calculation. There is no clear relation between the intensity of the railway damage and the horizontal inundation flow structure. Analyzing both longitudinal and horizontal structures of topography and inundation flow should be useful in evaluating the risk of the railway damage due to the inundation.

The structure of the inundation flow is determined by the structure of geographical features and the boundary flow conditions, and is not particularly sensitive to the uncertainty of a local flow and small differences in boundary conditions. Therefore, to predict the damage risk robustly and effectively, it is very important to pay attention to the structure of inundation flow and its relation to geomorphic conditions.
